# Manhole Inspection Summary

Manhole # S41AA\_046MH

Insp Date: **11/10/08 10:47 AM**

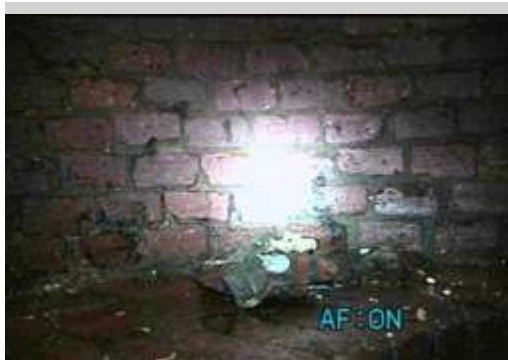
Defect 3

bench debris

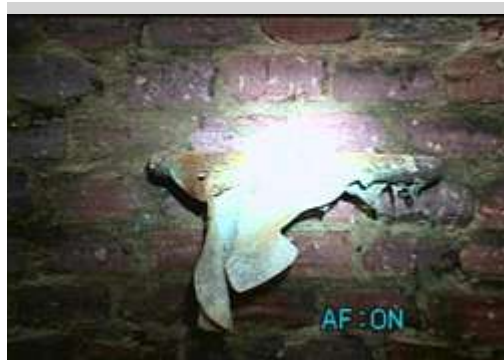
Defect 2

☒ **Evidence Of Surcharge**

Depth: **7.** (ft.) ☐ Active Surcharge Present

surcharge evidence 7.41 feet

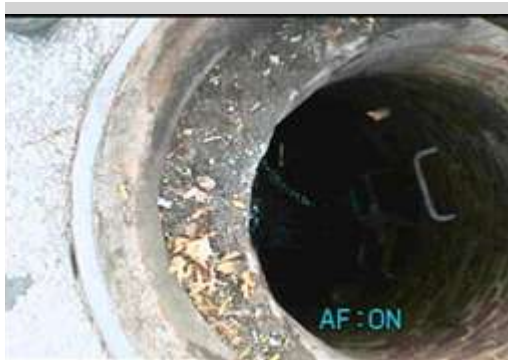
Defect 1

Offset: **4.5** (in.)

frame offset 4.5 inches

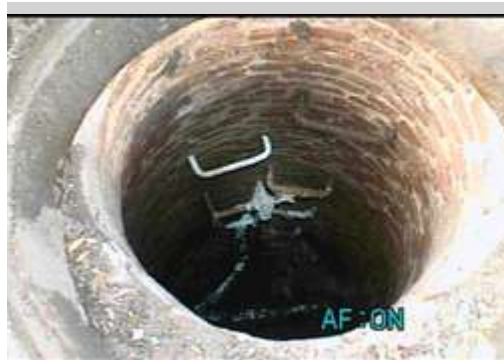
Count: **8** Missing: **0** ☒ **Corroded**

steps corroded

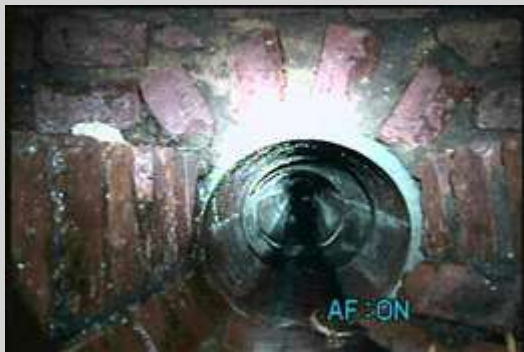
12 O'Clock Outflow

8 in. Circular Gravity Sewer  
Pipe Out @ 12 O'Clock

Invert Depth: 13.00 (ft.) Flow Characteristics: Slow

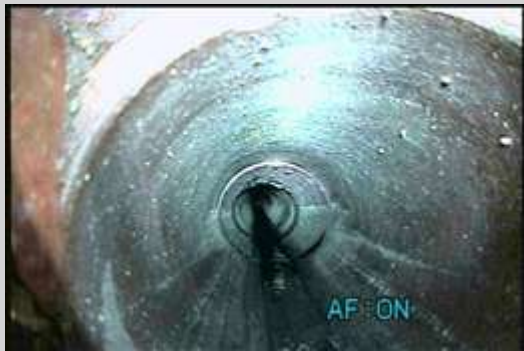
3 O'Clock Inflow

8 in. Circular Gravity Sewer  
Pipe In @ 3 O'Clock

Invert Depth: 12.92 (ft.) Flow Characteristics: Slow

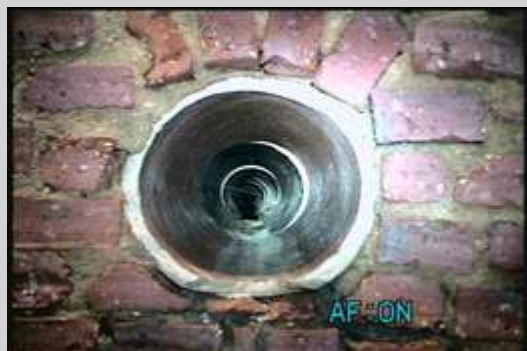
6 O'Clock Inflow

8 in. Circular Gravity Sewer  
Pipe In @ 6 OClock

Invert Depth: 9.00 (ft.) Flow Characteristics: Slow

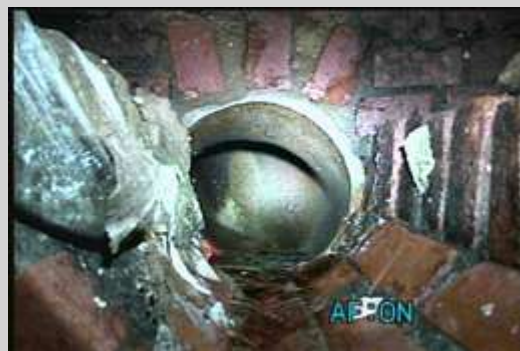
Drop In @ 6 OClock

Drop: Outside Direct

Inv Depth: 12.83 (ft.)

Drop Condition: Open
